Monitoring Data RecordProject Title: R-2210A Site 1 (Waynesville Site 1) COE Action ID: 200130653Stream Name: Raccoon Creek DWQ Number: 010409City, County and other Location Information: Sta. 30 on Bus. 23 S in Waynesville, Haywood Co.Date Construction Completed: July 2003 (lower portion), 2005 (upper portion)Monitoring Year: (3) of 5Ecoregion: _____ 8 digit HUC unit 06010106

Waynesville Site 1

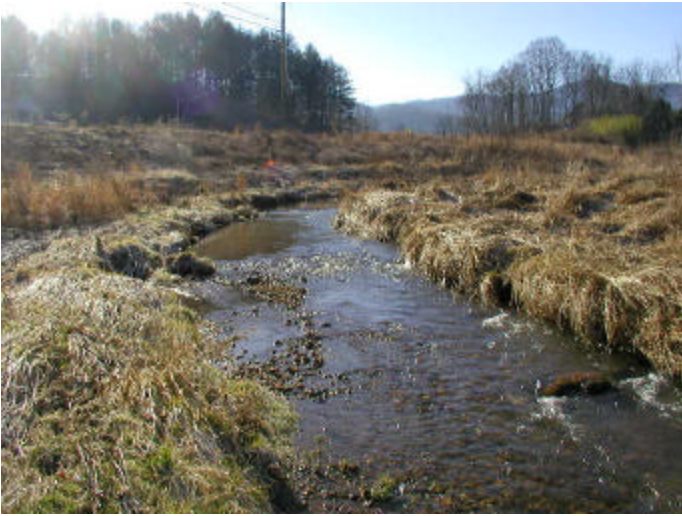
Photo 3 (Upstream)

Raccoon Creek is stabilized for the Year 3 Winter Evaluation. The minor bank erosion noted on past evaluations has stabilized with herbaceous vegetation. The j-hook in photo #3 has water flowing around this structure on the right bank. There is evidence that a bankfull event has taken place since the last monitoring visit. The overall stability of the stream is very good and no remedial action is needed at this time. NCDOT will continue to monitor this stream.

Date Inspected	Station Number	Station Number	Station Number	Station Number	Station Number
Structure Type	J-Hook				
Is water piping through or around structure?	Around Structure				
Head cut or down cut present?					
Bank or scour erosion present?					
Other problems noted?
